Anode Life Case Study

Summary

Full Report

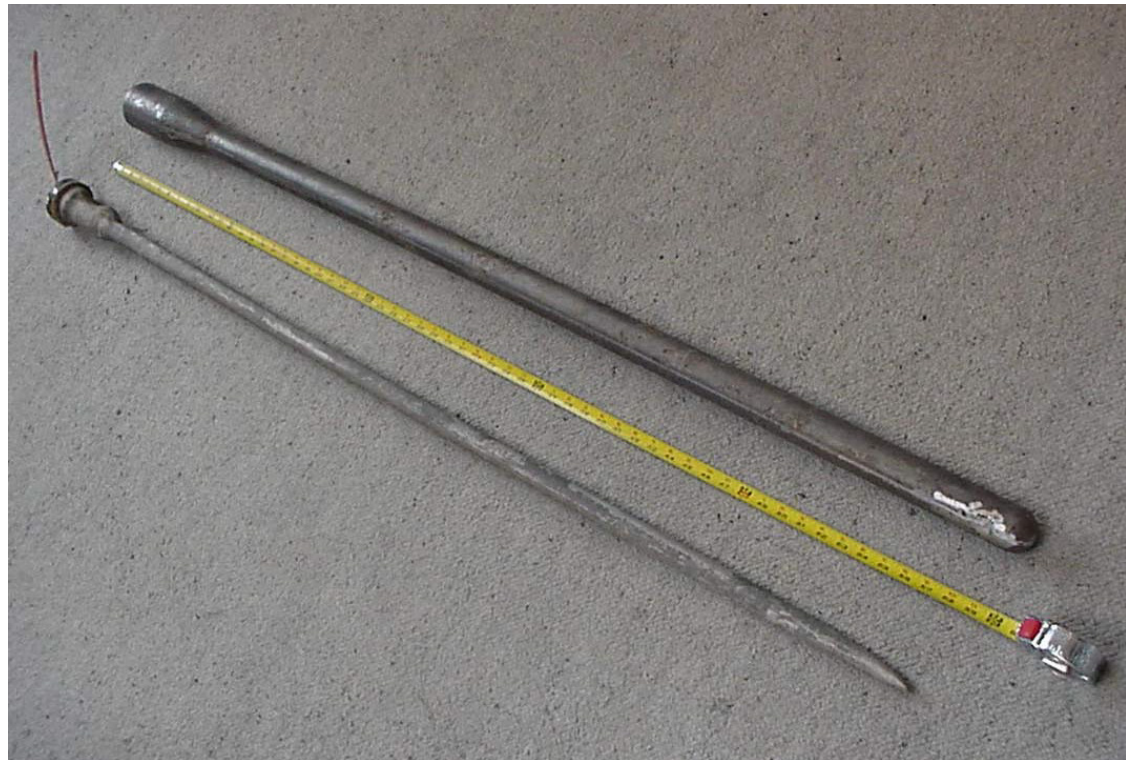
In 1998, a specimen Anotec chill cast 2 in. x 60 in. (EHA) solid stick anode was recovered from natural seawater by West Coast Corrosion after 24 Ampere-Years of service at 4.86 Amps (average). The specimen, without failing in service, weighed 13.75 lb when recovered. Inspection indicated that an additional 4 to 5 pounds could have been utilized, indicating 75% utilization. The 65% utilization factor often assumed for ground bed design seems conservative.

The figure below shows the as-recovered anode beside a new 44 lb equivalent.

The as-recovered anode weighed 13.75 lb, equivalent to 69% utilization of the original 44 lb weight.

Based on the 24 Ampere-Year service, consumption equates to 1.28 lb/Ampere-Year at the current densities experienced (1.5 to 3 Amps / sq. ft. based on the original 2.6 sq. ft. surface area of a virgin EHA anode). [Note: Consumption rates of 0.75 to 1 lb / Ampere-Year are normally projected for high silicon cast iron operating at discharge current densities up to 1 Amp / sq.ft.]

It is our considered opinion that the anode would have continued to operate until another 3 - 5 lb of mass had been consumed, equivalent to a utilization of 75 to 80%. [Note: A 65% utilization factor is often assumed for solid rod anode groundbed design.]

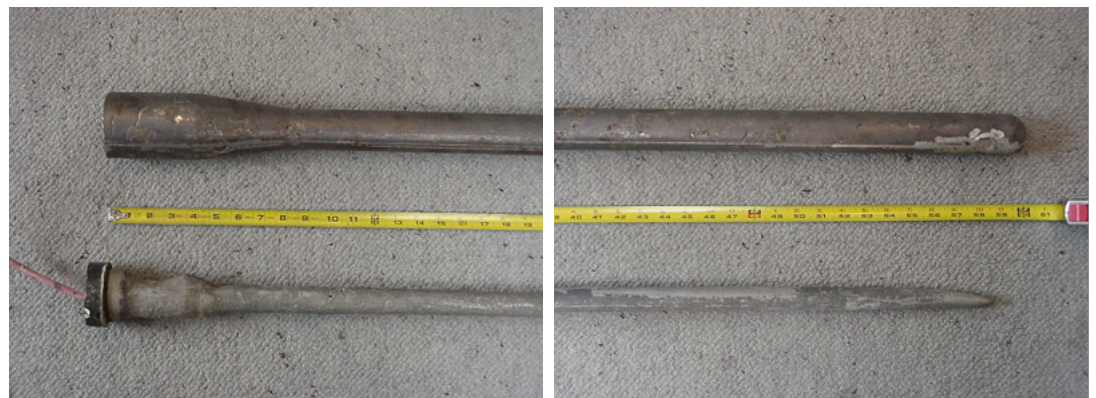
Effects of consumption (refer to the photographs below):

- Length of the anode decreased by 2% (from 59.7 in. original length, to 58.5 in. as-recovered length).
- The end of the anode, opposite to the cable connection, which was originally a hemispherical tip of 2 in. nominal diameter, eroded away to 5 in. long tapered point.
- Mid-length diameter decreased from 1.9 in. to 1 in.
- The cable connection (expanded head end) showed "necking-in", spanning about 3 in. of head length, commencing about 0.5 in. from the epoxy cap. This resulted from the Polyken tape epoxy-mold, but was enhanced due to the location of the (sand) pouring cup (compared to the rest of the anode being in direct contact with the metal mold). As a direct result of this finding, the sand pouring cup was relocated to the other end of the anode.
